**APPENDIX D:
EXAMPLE CONCEPTUAL SITE MODEL**

Example Conceptual Site Model

Building S-15 (DSERTS Site #8) is located on a hill within CEKSF's main post near Oakdale, PA. Building S-15 is located in Allegheny County, Pennsylvania approximately 10 miles southwest of Pittsburgh. Historically, Building S-15 was the primary generator building of the NIKE Missile Master Control Facility. After the site was

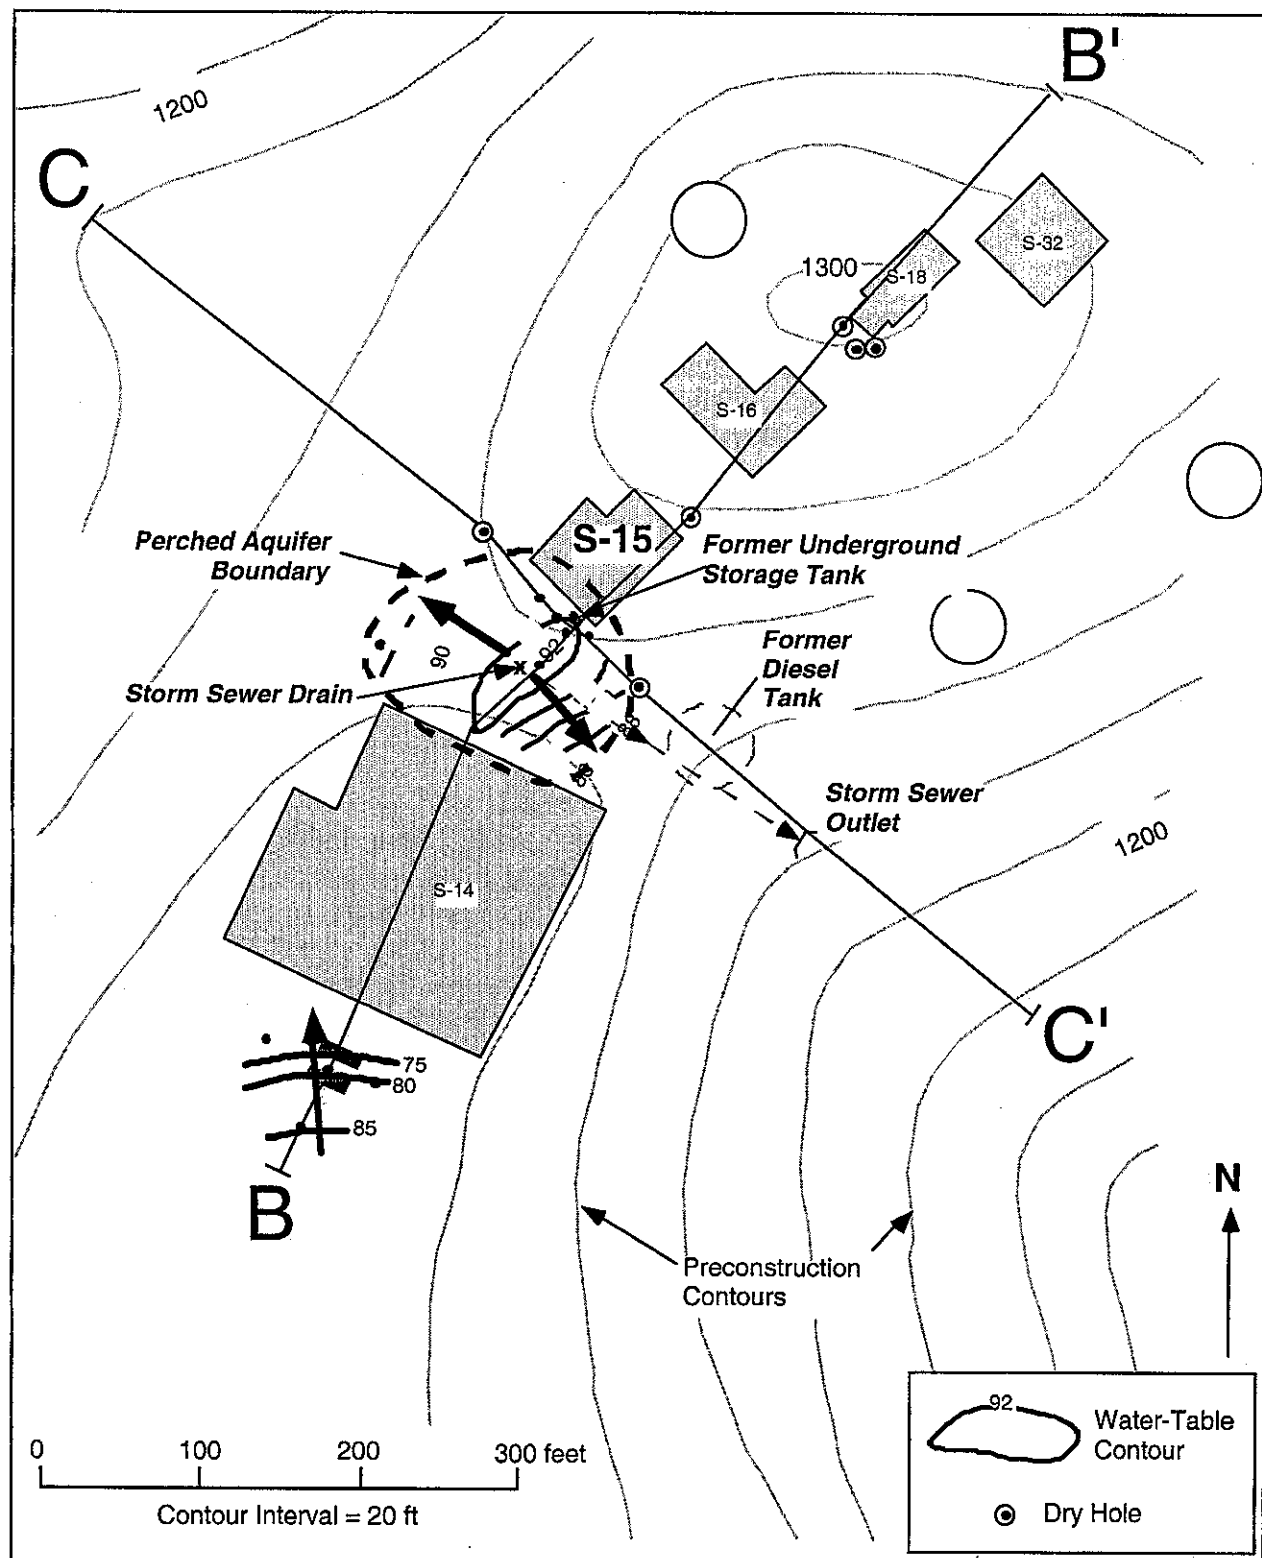
Building S-15 (Figures 2 and 4). Based on a water level survey performed at Building S-15 in July 1995, a near-surface aquifer of limited areal extent is approximately centered over, and moves radially away from, well MW-5 (Figure 4). Other subsequent water-level surveys performed in August and September of 1998, and July 1999 (Table 1), corroborate the existence of this perched aquifer in the surficial silty clay layer. The mounded aquifer, with a hydraulic gradient up to 0.13 ft/ft or 7.4 degrees, does not appear to extend far laterally beyond the saddle (Figure 4).

The near-surface groundwater mound is coincident with a storm sewer drain that collects water running off the Building S-15 parking lot (Figure 4). It is possible that this storm sewer leaks leading to the development of the groundwater mound. The perched groundwater mound may also be topographically controlled, since it lies within a saddle, and therefore may be collecting groundwater from higher-elevation areas along the ridgeline (Figure 4). Another scenario for the source of the groundwater mound is from enhanced recharge associated with a roof drain that discharged water into an unpaved portion of the asphalt, where the 650-gallon UST used to be. This situation existed between tank removal (1994) and July, 1998, when the area over the excavated tank was paved. In 1997, it was discovered that many of the flush-mounted well housings were defective and leaking; these may also have resulted in recharge to the uppermost groundwater zone in the vicinity of Building S-15. The defective well housings have since been repaired (Schalla and Newcomer 1998).

Figure 4. Potentiometric Surface of Uppermost Perched Aquifers

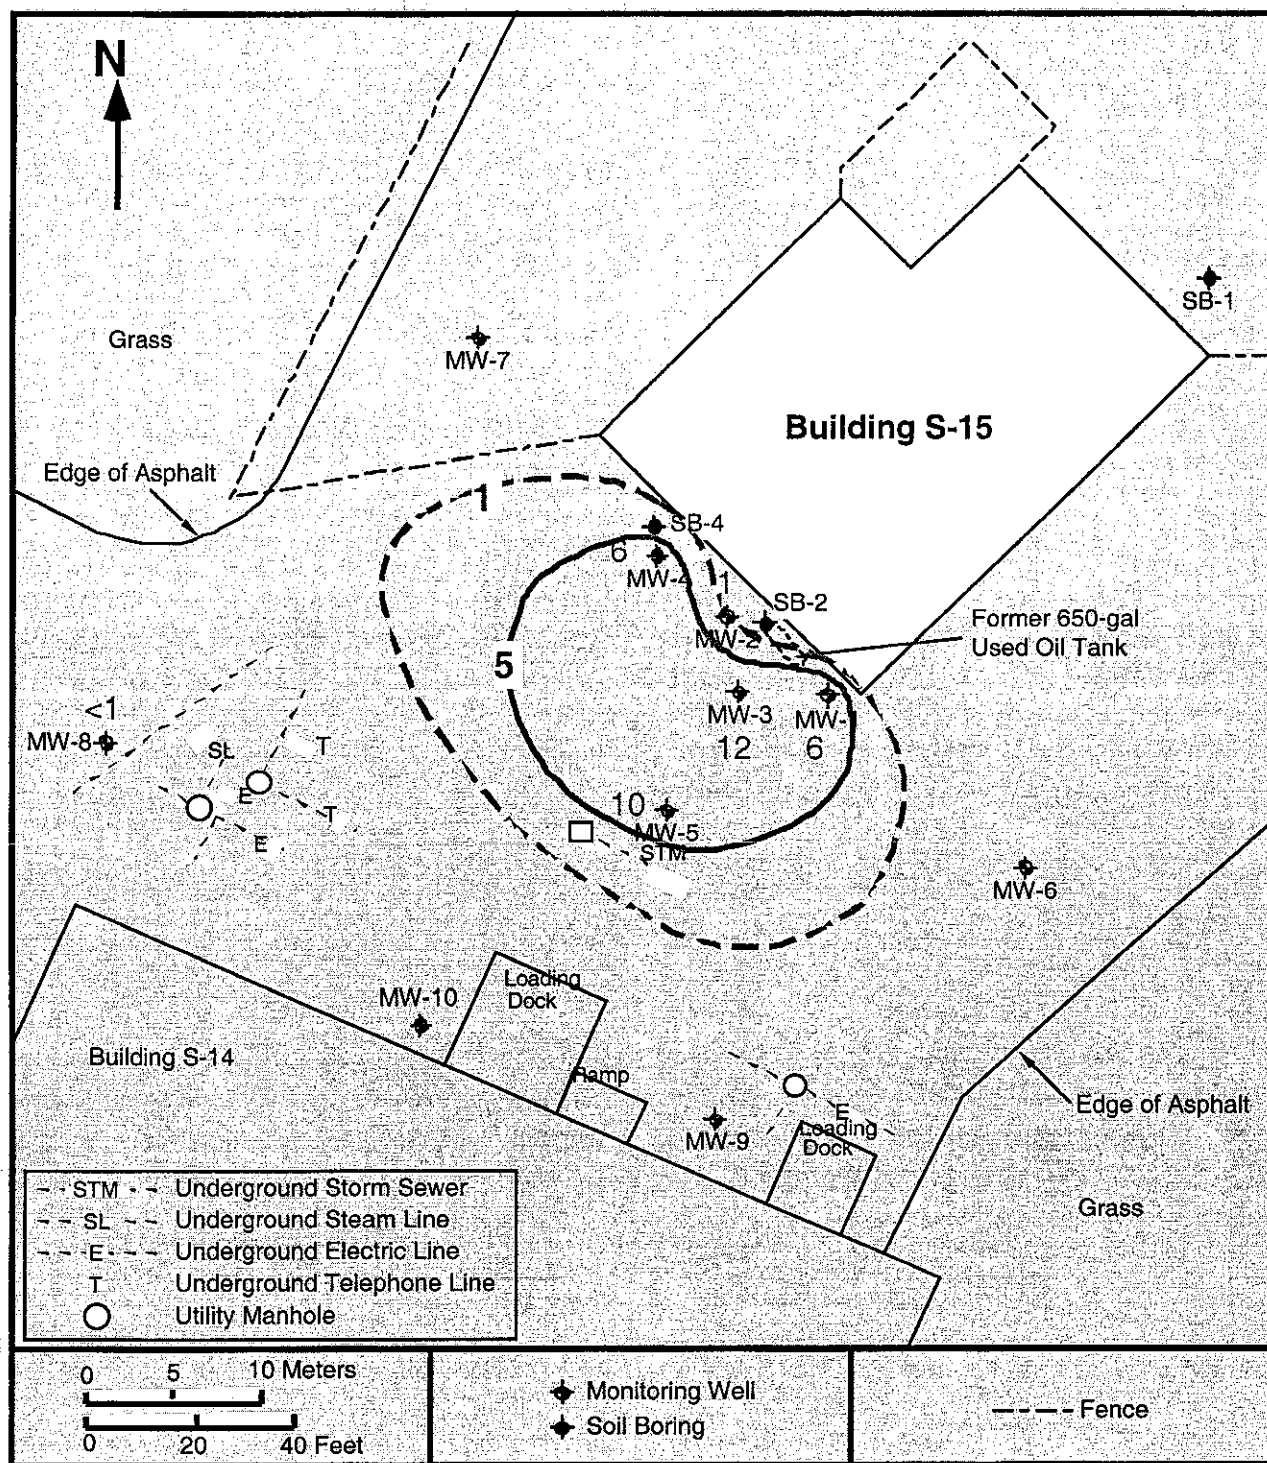
Thus, to date all contaminant concentrations have been compared to the Statewide Health standards. Based on these standards, the primary concern at the site is the presence of benzene, trichloroethene, 1,1-dichloroethane, and naphthalene. Benzene has been detected in 4 monitoring wells at levels between 1 and 3 times the 5 µg/L standard. Trichloroethene has been detected in a single well at a level greater than 4 times the 5 µg/L standard. 1,1-dichloroethane has been detected in 3 wells at levels above regulatory standards (up to 3 times the standard). Naphthalene has been detected in 3 wells at levels over 2 to 4 times the 20 µg/L standard. The wells are completed in a perched aquifer that does not extend off site. However the extent of contamination with depth has not been determined.

Figure 6. Concentration of Benzene in Groundwater ($\mu\text{g/L}$), October, 1998.

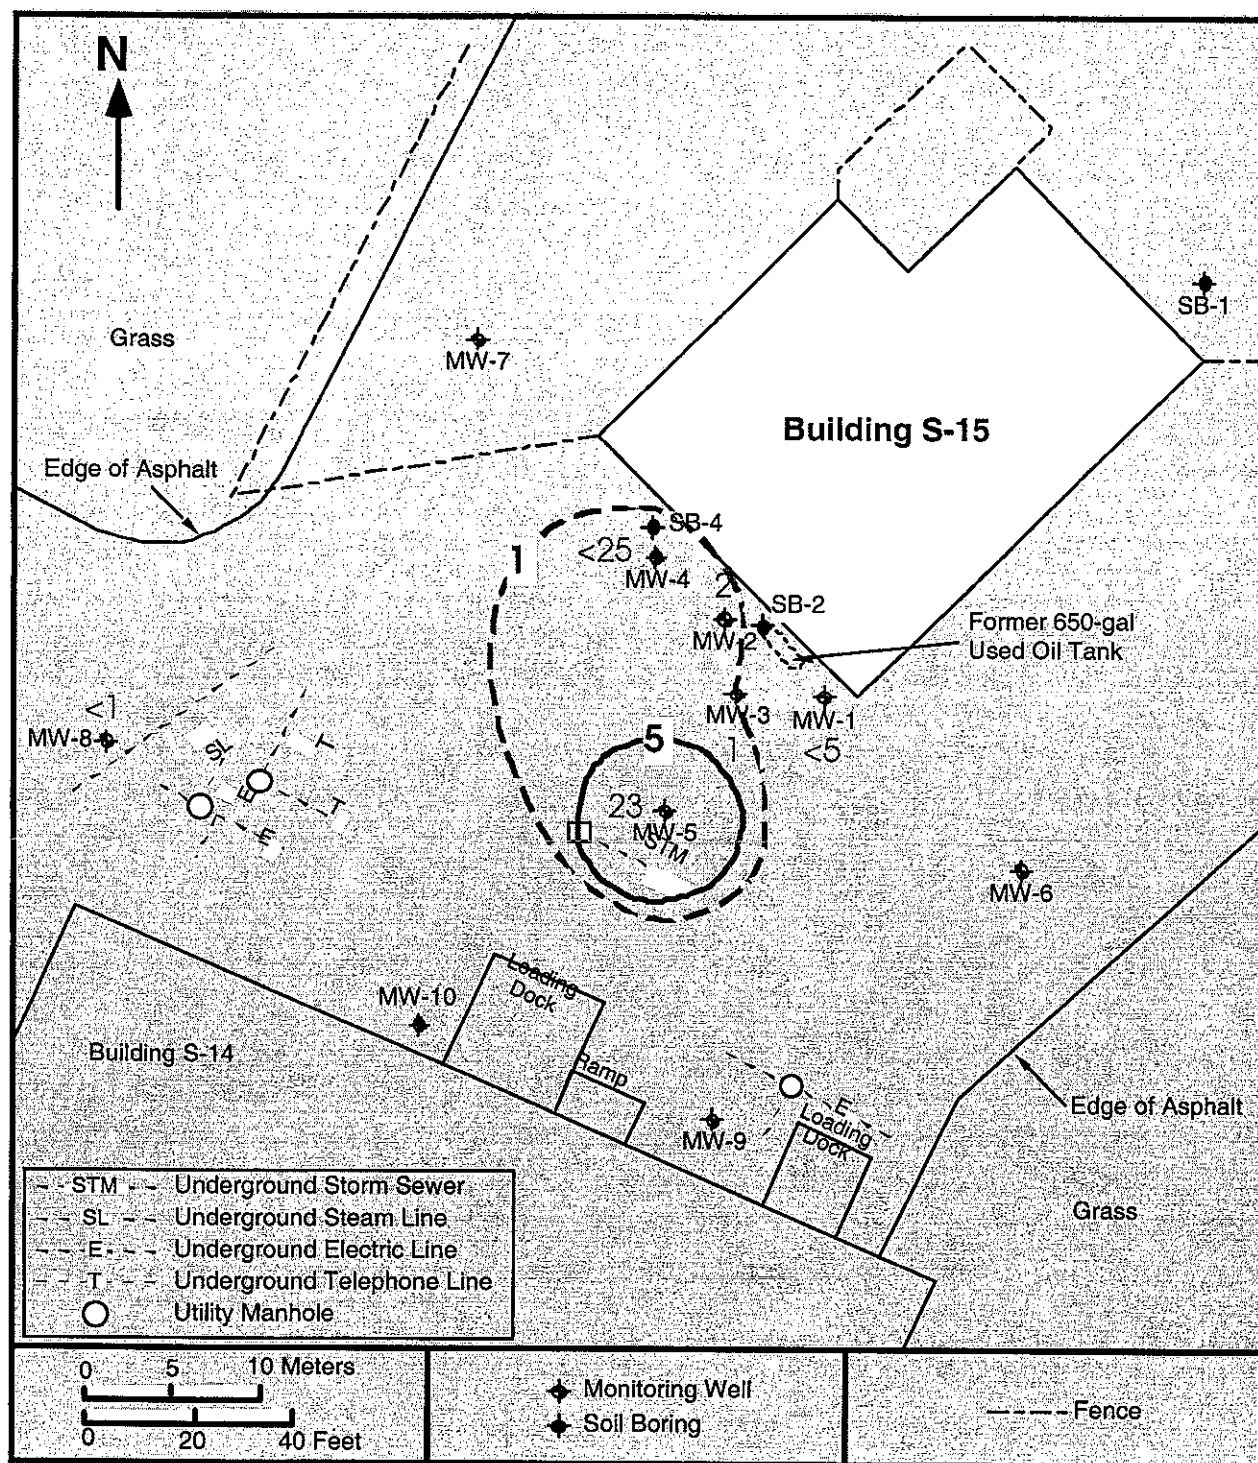
Figure 7. Concentration of TCE in Groundwater ($\mu\text{g/L}$), October 1998.

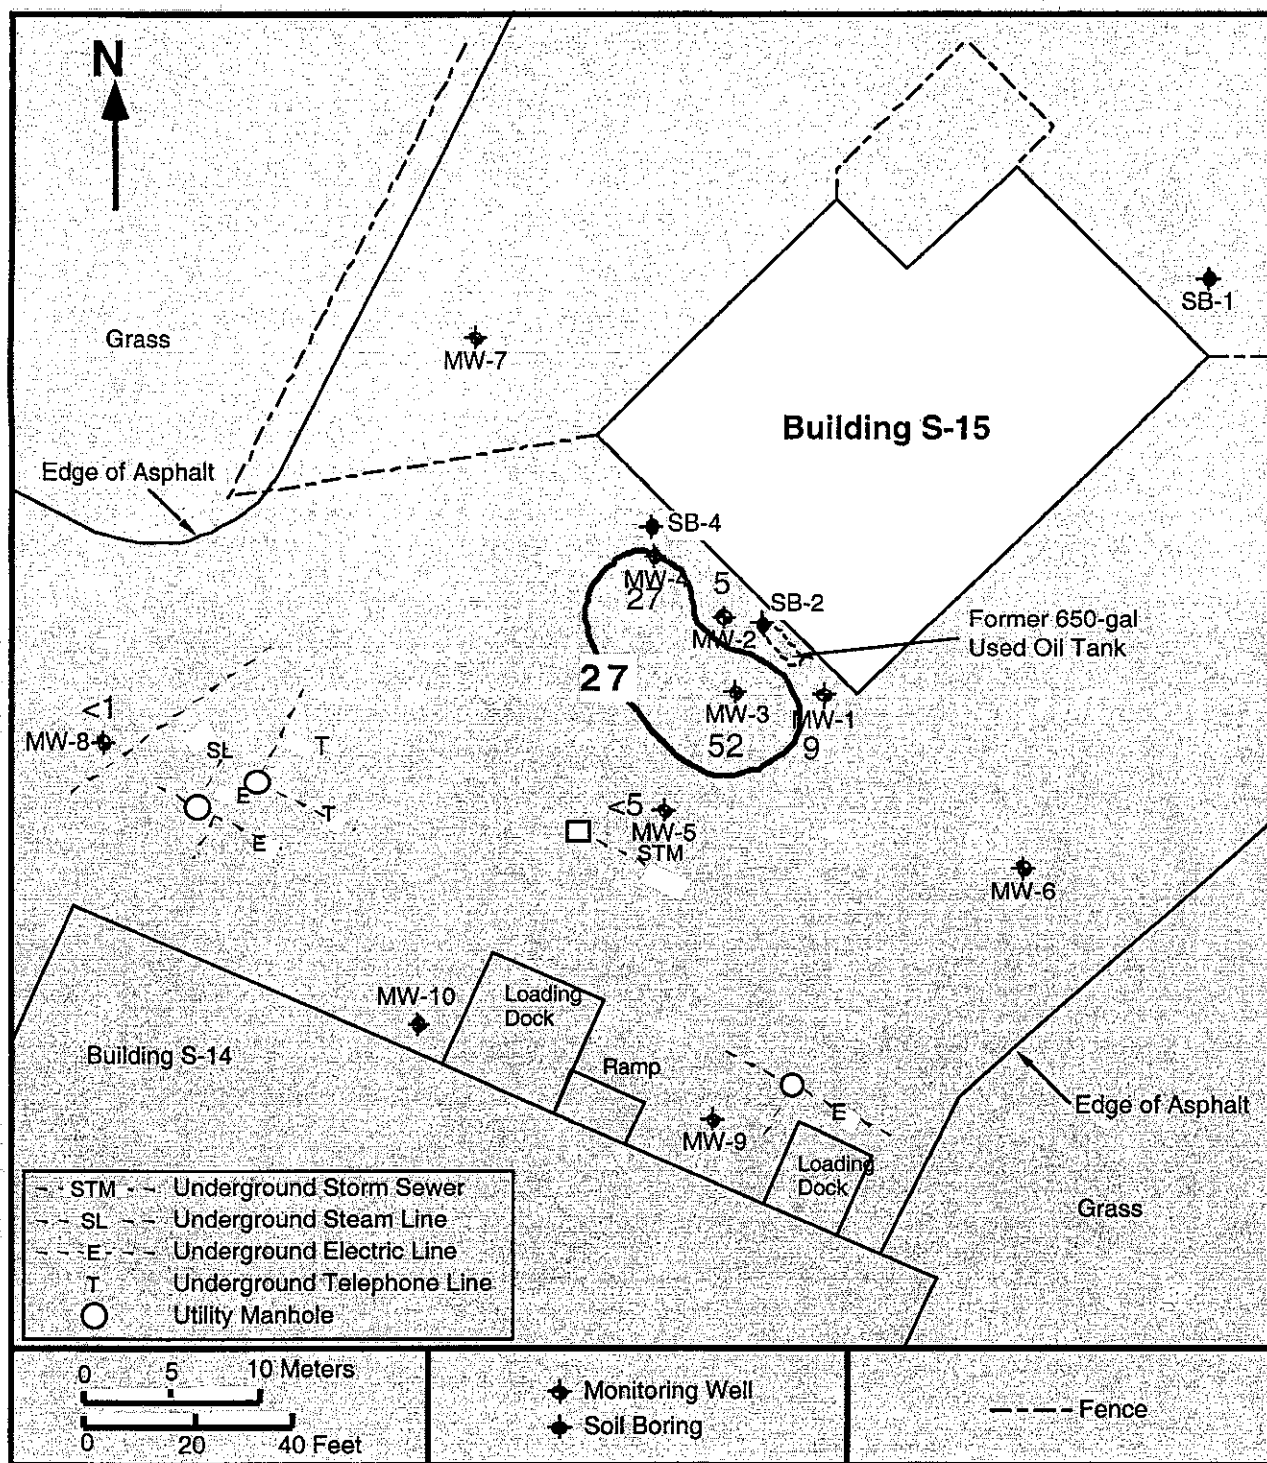
Figure 8. Concentration of 1,1-DCA in groundwater ($\mu\text{g/L}$), October, 1998.

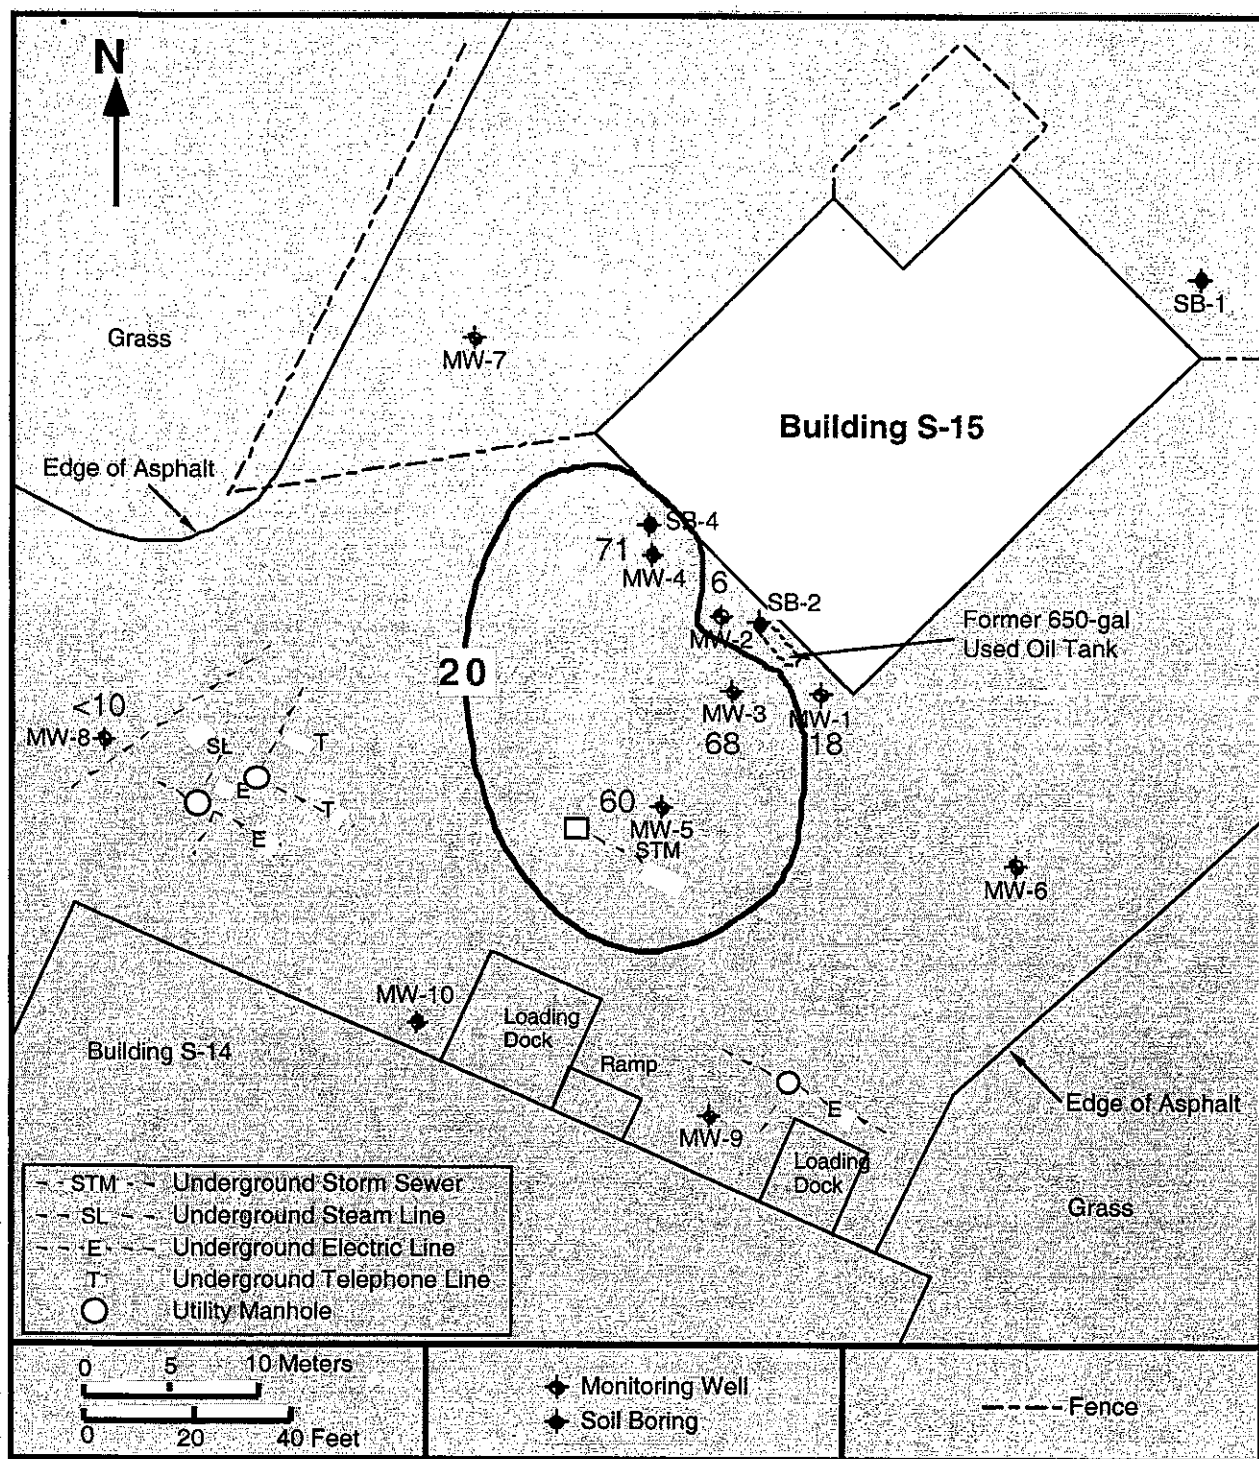
Figure 9. Concentration of Naphthalene ($\mu\text{g/L}$), October 1998.

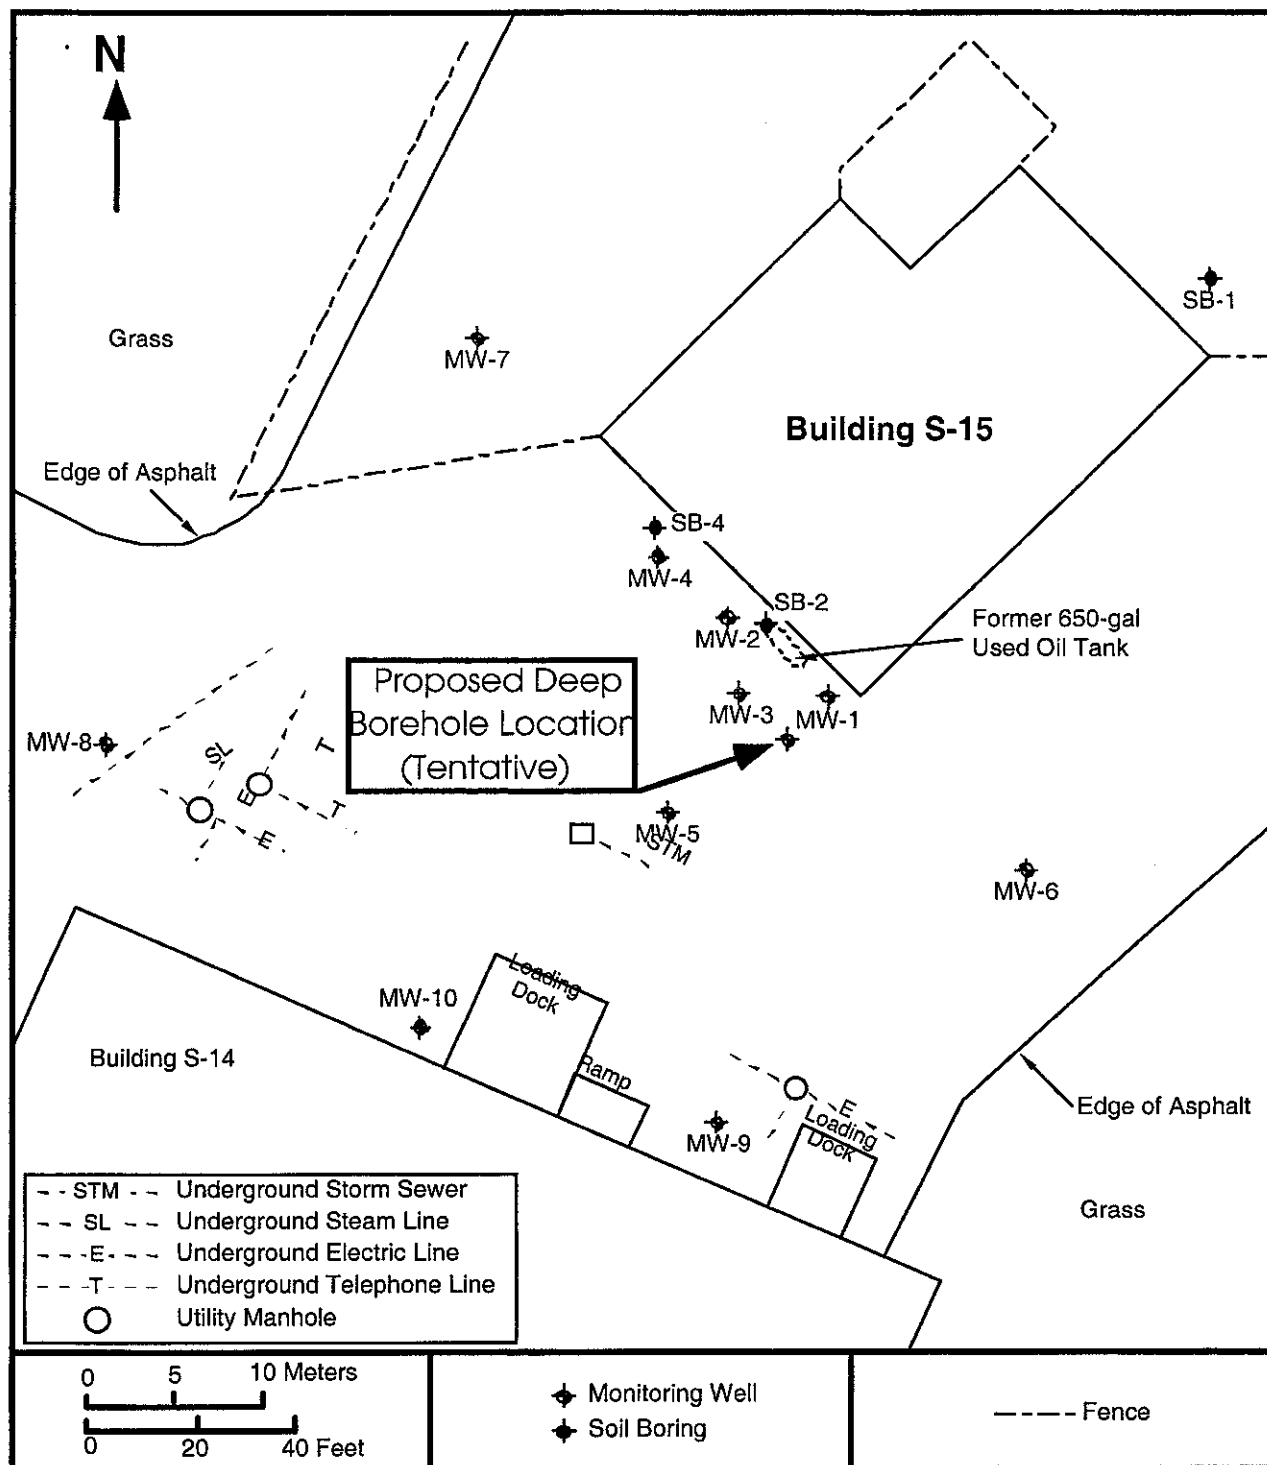
Figure 10. Proposed Deep Borehole Location.

Additional data are needed to assess the presence and impacts of lower perched aquifers. A proposed well to be drilled at the site would be used to decide if lower perched aquifers are present and are contaminated. In addition, the presence of contamination in springs and seeps has not been assessed. If contamination is not detected in lower perched aquifers and is not detected in springs, then this will be considered evidence that significant impact from the site is unlikely. Hence it is extremely important that the proposed test well be drilled and completed very carefully so as to not drag or smear contamination along the section.
